DM2000: A Powerful Tool for Asset Management

Hainan Fudao Chemical Industry Co. Ltd. (HFCI) is located in Dong Fang, Hainan province, in the southernmost part of China. Construction began in 1994 and the facility was commissioned in 1996. There are two main divisions: an ammonia plant and the first granular urea plant in China. Production capacity is 1000 MTPD (metric tons per day) of ammonia and 1765 MTPD of granular urea. Both products are used as fertilizer.

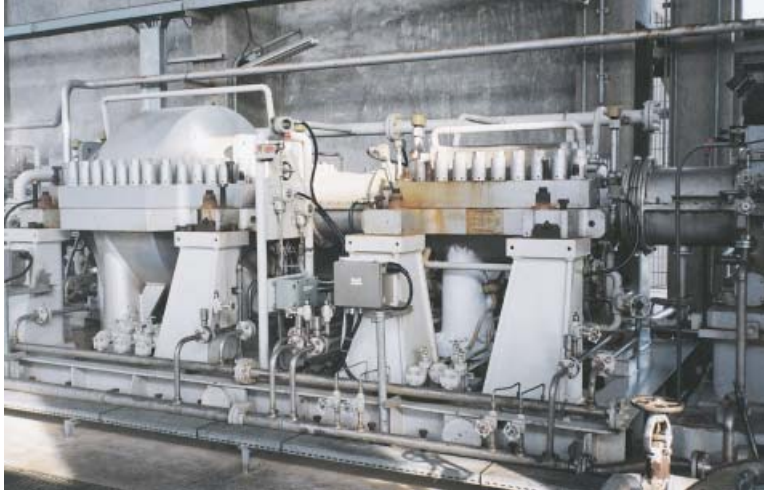
Case History #1 - Refrigeration ammonia compressor.

In March 2000, the ammonia unit was tripped by excessive thrust position on the steam turbine. Ten minutes later the operator tried to restart the unit but failed due to excessive thrust position again. DM2000 automatically collected the data during alarm and shutdown conditions, as well as from the period leading up to the alarm. Baseline data was collected when the machine train was under normal operation. This information proved to be very useful in identifying the source of the problem.

confirmed that something was wrong in the rotor's axial direction. Other DM2000 data was reviewed as well, but the radial vibration at each bearing did not change much compared to the baseline data. There was no indication, for example, of a radial rub or other anomaly. It was concluded that thrust bearing damage had probably occurred and plans

were made for Maintenance to replace the thrust bearing only. When the bearing was opened up, suspicions were confirmed: the Babbitt metal was severely damaged. After thrust bearing change out, start up was smooth and the machine operated without further problems.

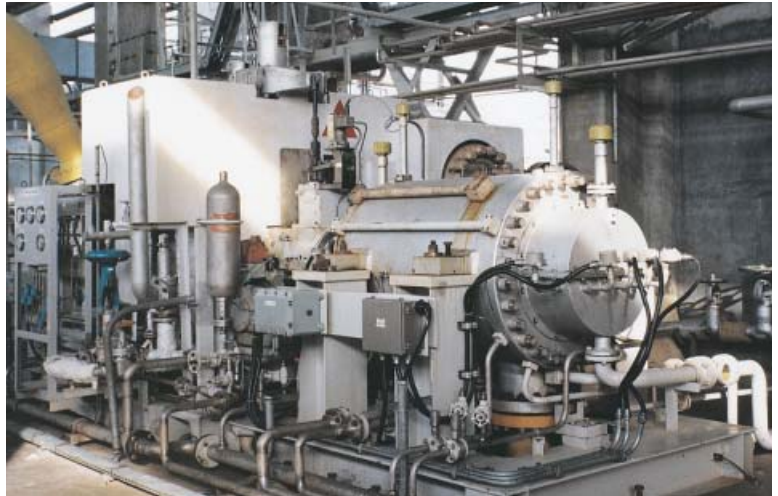
Case History #2 - CO₂ compressor.

On 5 January 2000, the CO₂ unit was tripped when another part of the process was brought down. Shutdown data analysis did not identify anything abnormal. The following morning, a fully automated restart was attempted using the Digital Electric-Hydraulic (DEH) unit control system. During start up the steam turbine tripped at 2905 rpm due to high vibration. Operations had witnessed the

A Bode plot (Figure 7) was then analyzed. It showed a distinct difference from normal startup behavior, as noted by comparing the baseline data in Figure 7 with the data collected during the aborted startup. A change in balance seemed unlikely, and the immediate suspicion was thermal bow.

It was suspected that the shaft bow resulted from an inadequate startup procedure that did not allow the rotor to warm up and expand properly. A unit restart, using a manually controlled procedure, maintained 1000 rpm for 15 minutes and allowed the rotor to fully warm up and expand. Automated control via the DEH system was resumed and the rotor was ramped up to operating speed. The entire startup was monitored closely, viewing appropriate DM2000 data. Smooth operation was observed throughout and vibration amplitudes were less than 50 μm . This modified startup procedure was determined to be feasible and effective for the CO₂ unit and has been permanently implemented.

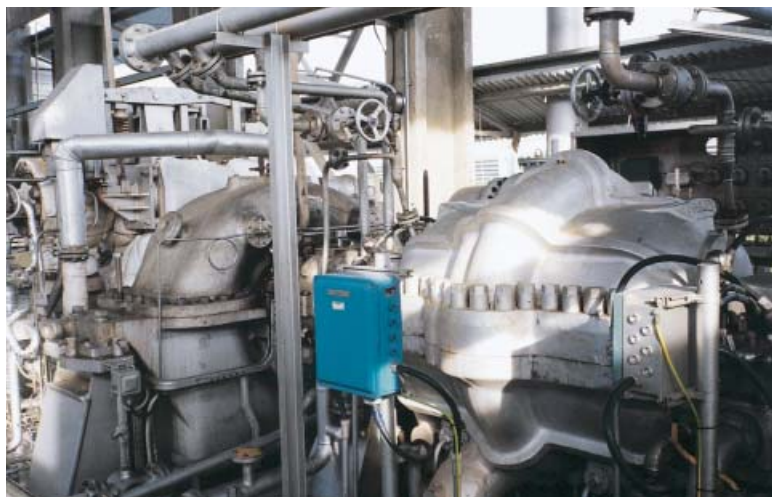
Case History #3 - Synthesized gas/recycled gas compressor.

During a regularly scheduled shutdown on 24 June 2000, the rotor speed suddenly (within 7 seconds) increased to nearly 5000 rpm after having coasted down to 920 rpm. Operations personnel were not able to explain this. The main valve had already been closed and the control system displays did not provide any information.

different vibration amplitude and phase was noted from 920 rpm through 4850 rpm than was typical of a startup through the same speed region. A full spectrum waterfall plot (Figure 9) was also examined and revealed a significant reverse precession component, far bigger than the forward component. At this point, it was thought that rubbing may have occurred. However, upon further investigation, the shaft centerline position plot (Figure 10) indicated that reverse rotation rather than reverse vibration had actually occurred. This is illustrated in Figure 11. Please note that the radial bearing used in this machine was a five-shoe, tilting-pad design.

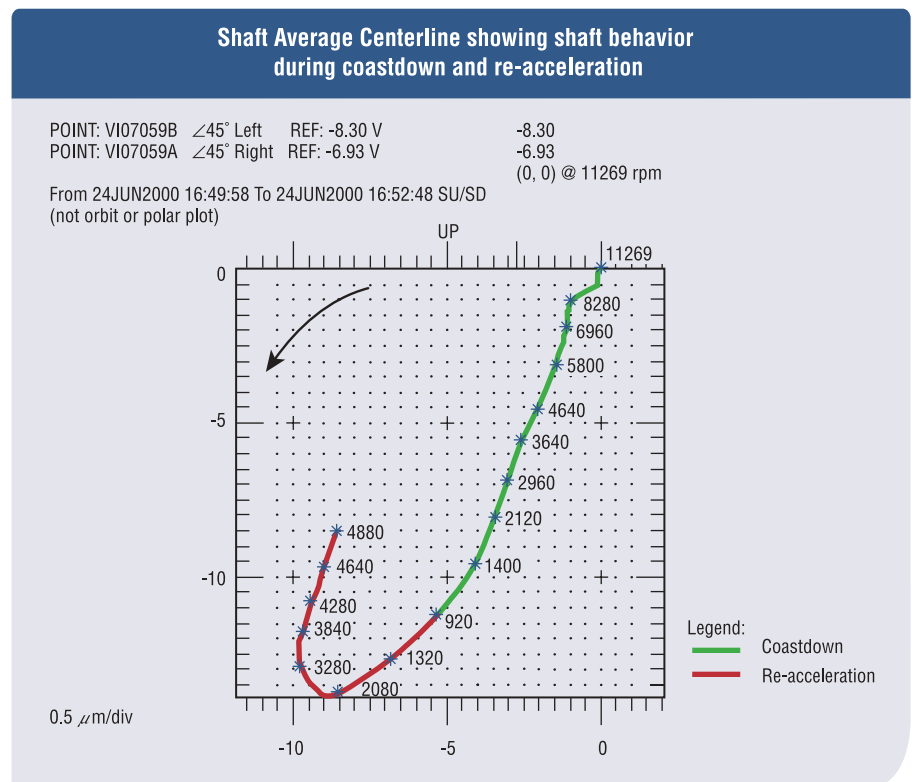
Figure 10.

For a Load-on-Pad (LOP) configuration of tilting-pad bearings, the shaft supporting oil wedge is established and position is maintained on the bottom pad. Due to the location of the wedge, the shaft rises essentially straight up into normal running position, although there is a slight offset from the true vertical centerline. Usually, the offset is in the direction of rotation as shown in Figure 11. In general, for a specific bearing, the centerline position will retrace the same pattern each time the machine is started or stopped. Figure 10 shows that as the machine coasted down from 11,269 rpm, the shaft centerline followed a predictable path from slightly right of center toward the bottom of the bearing clearance. This would be predicted from Figure 11. However, when the machine suddenly accelerated from 920 rpm to 4880 rpm it did not retrace the same path of upward and to the right. Instead, it traveled down through the vertical centerline of the bearing clearance and then

upwards and to the *left* – the exact opposite direction one would expect. The combination of reverse precession seen in the full spectrum plot and the data from the shaft
